TOTEM DAM

(NDI I.D. No. PA-00042,

PHASE I INSPECTION REPORT

NATIONAL DAM INSPECTION PROGRAM

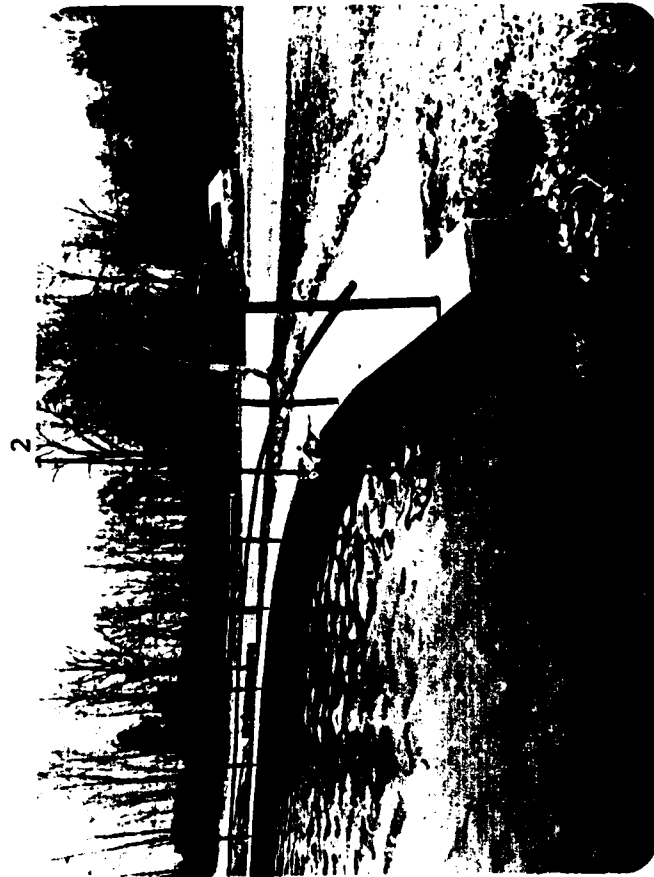
b. Embankment. Observations made during the visual inspection indicate the embankment is in good condition. The most visually apparent deficiency observed concerned cracking of the upstream concrete wall and crest cap. A 25-foot longitudinal crack is located several feet from the left abutment (see Photograph 3) while an additional area of broken concrete is located about 10 feet from the right abutment (see Photographs 2 and 4). Minor cracking was also observed along the wall below the pool level between the spillway and right abutment.

PHOTOGRAPH 3 View of a structural crack in the concrete crest cap near the left abutment.

c. Repair concrete deterioration wherever necessary, including along the crest and downstream spillway face.

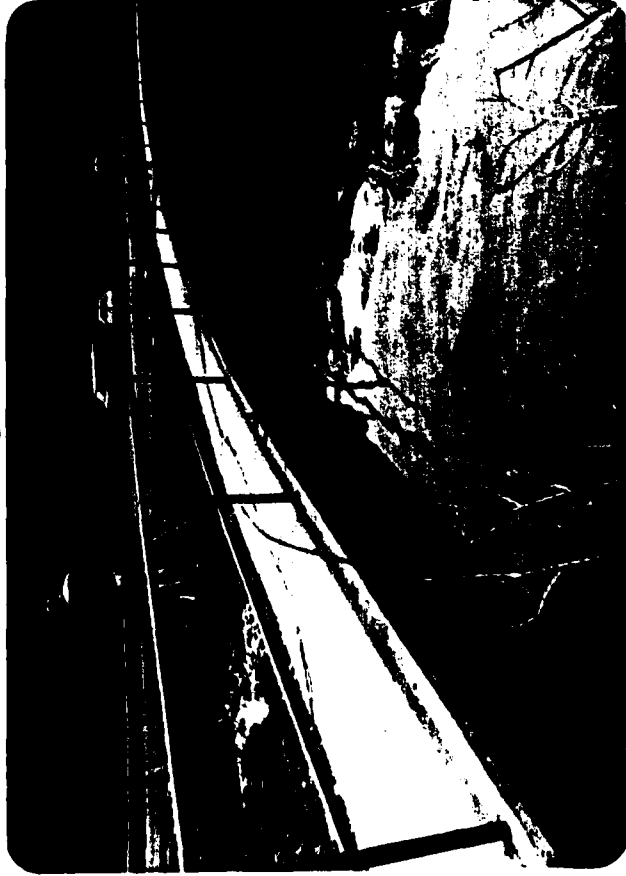
7

owner who acquired the facility in 1966. Consequently, its operability is questionable. The gate control along the upstream embankment face appears securely mounted; however, some surficial corrosion was observed (see Photograph 7). Minor leakage was observed at the discharge end of the conduit, but, was not measurable (see Photograph 8). The apparent plan of the outlet conduit does not conform to the design drawings.

d. Check the present operability of the outlet conduit control valve and initiate repairs, if necessary. In addition, the conduit should be operated on at least an annual basis and preventive maintenance performed concurrently.
